Bio-Engineered Stream Bank Stabilization on the Teton River

by Katie M. Salsbury, Principal,
Intermountain Aquatics and Native
Sod Solutions

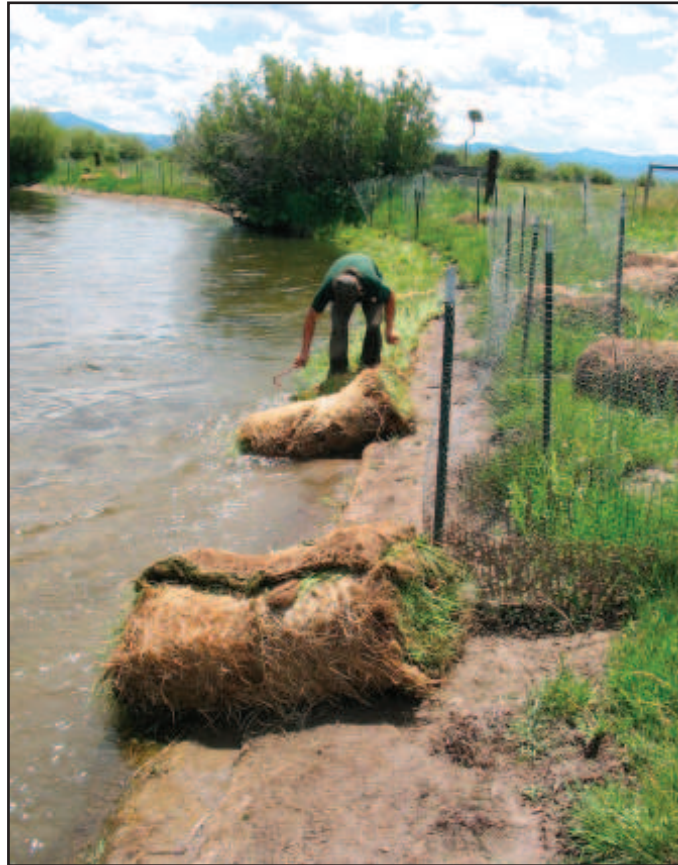
Wetland Sod installation.

Because installation of the Wetland Sod during the fall would not allow the plants to root before the peak, run-off event; it was installed using 12-inch lath staking every 8 square feet after the spring run-off in July of the following year. A temporary irrigation system was used at each site to irrigate the projects through the first growing season.

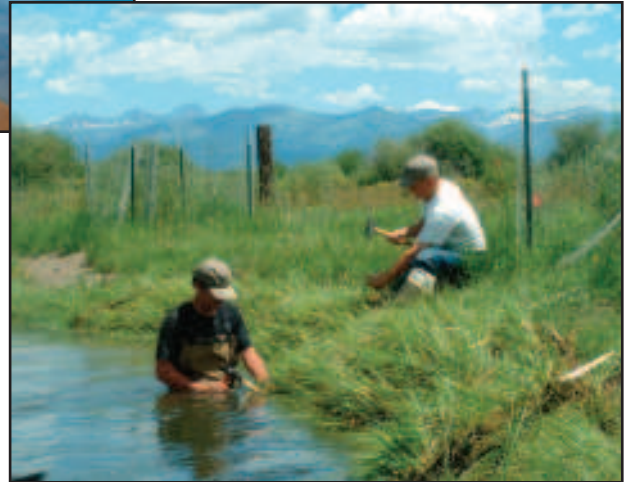
Top: Construction of the first soil terrace. Lower: Site conditions during Wetland Sod installation.

Two layers of erosion control fabric were staked onto the base of the excavated bank using 8-inch wire staples. Soil was compacted onto the erosion control fabric layers to a depth of 10 inches. Approximately 3 feet of the erosion control fabric was wrapped up onto the compacted soil to build the initial toe and first terrace of the reconstructed bank. On most sites, this technique was repeated to construct a

second terrace, off-set by 3 feet from the lower one. The remaining soil was sloped back to create a bank with an average slope of 4:1. Disturbed areas were seeded with a xeric mix and 5 gallon, containerized willows and dormant willow cuttings were installed above the second soil terrace. This work was completed in the late fall of each year to insure that the terraces were constructed during base-flow conditions.

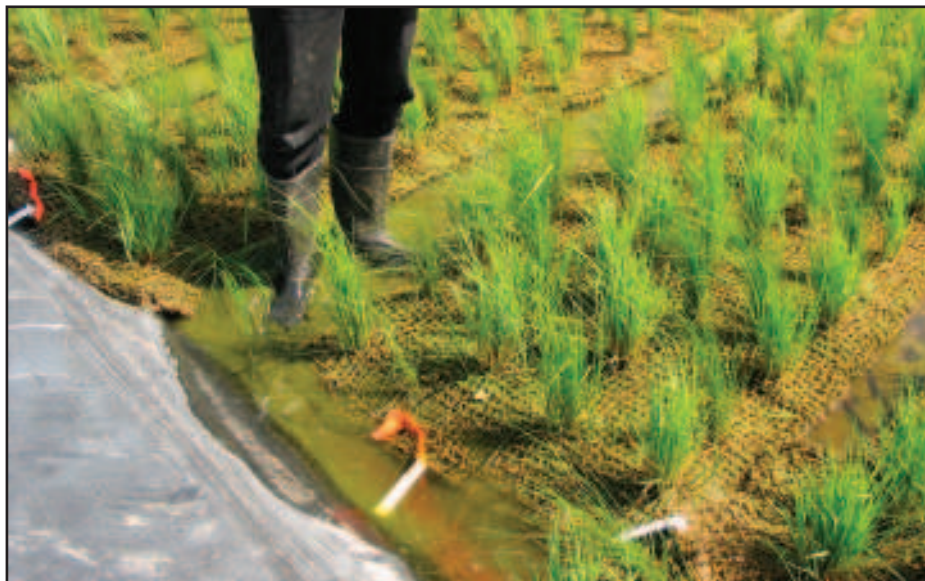
The pre-planted erosion control mat is grown with native plants to produce maximum root growth.

Wetland Sod was developed and tested to rapidly establish key wetland species on wetland restoration and mitigation sites. It is a pre-planted erosion control mat grown with native plants to produce maximum root growth.
