Bio-engineered Stream Bank Stabilization Using Wetland Sod on the Teton River: A Case Study

Author: Katherine Salsbury

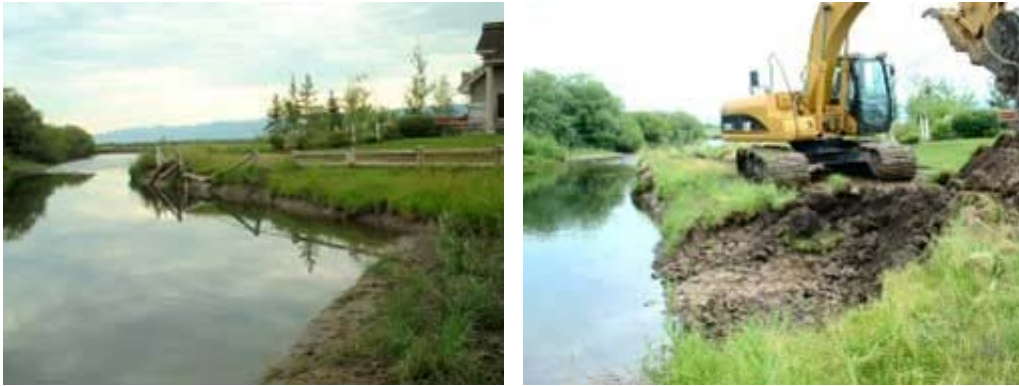
Photos taken over the course of 4 days pre and post construction.

The existing bank was reconstructed by first excavating the bank down to the base-flow water line to a width of 3.66 m. Two layers of long-term erosion control fabric were staked onto the base of the excavated bank using 20 cm wire staples. Soil was compacted onto the erosion control fabric layers to a depth of 0.30 m. Approximately 1 m of the erosion control fabric was wrapped up onto the compacted soil to build the initial toe of reconstructed bank. The remaining soil was sloped back to create a bank with an average slope of 3:1. Mature wetland sod TM pre-grown with native sedges and rushes was installed in two rows onto the constructed toe and remaining bank to a width of 1.83 m. A total of 77 m of eroding bank was reconstructed in 2 days at a cost of \$100 per linear meter. In 2.5 weeks post construction the wetland sod material was fully rooted and could not be displaced by human or livestock disturbance.

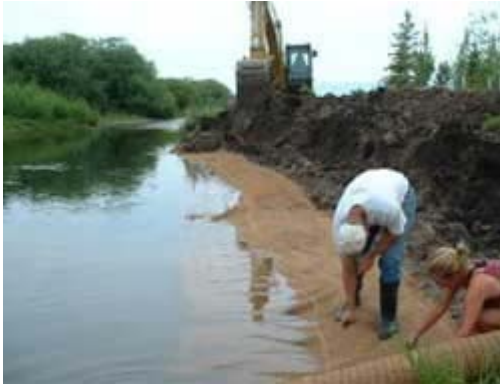
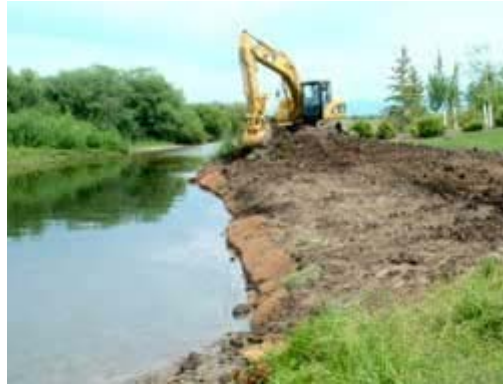
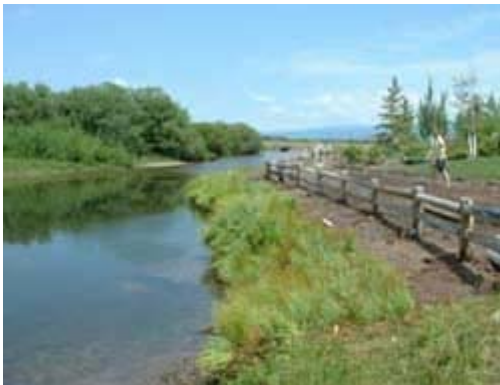
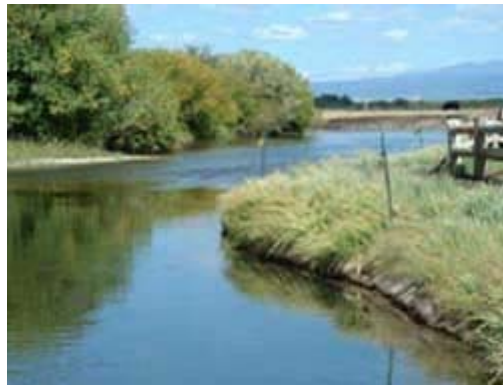
- 1. Remove sod and topsoil.*
- 2. Build soil terraces w/ erosion control fabric.*
- 3. Install wetland sod.*
